Basis Weight Unstability Evaluation & Stabilization Using Process Upgradation

Singhal D. K & Agarwal Sumit

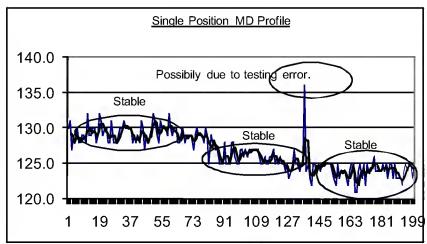
Figure-1: Single Position MD Profile

As indicated from the plot, we may observe that-

- The plot may be considered as consisting of three different segments, each one having fairly stable (for the time being) basis weight.
- There is a decrease in average basis weight by approx. 6gsm. This is against the information provided by the plant personnel that no change in basis weight

valve opening or the head etc. was made during production of the roll being considered.

- Between first two zones, there is a sudden decrease in GSM.
- It can be seen that after every 7-8 data points, there exists a peak. Considering a 2M difference between the samples, the peak-topeak spacing comes out to be 16M approx. For a machine speed of 230mpm, this matches to a pulse having (=230/16) 14-15 rpm frequency. As indicated above, the same could be due to holey roll no. 1 of the head box.

The above data suggests that there could be pulsations from different sources including holey roll, pressure screen, improperly designed approach flow piping etc. To begin with, holey roll no. 1 as indicated above was taken out and checked. It was straight and not bent as estimated earlier. So it was mounted again. But, single position MD profiling did not improve at all. So, during the next shut, a dial gauge was

mounted to check the ovality of the holey roll in position. A wobbling rotation was confirmed by 1.8mm over its circumference. Since the roll had already been checked, the bearings were replaced considering it as a source of the problem. The dial gauge testing was satisfactory this time and only a minute 0.35mm wobbling was observed. Later, it was observed that the earlier bearings had many scorings on their outer race, which could have been a reason for the wobbling of the roll.

As further improvement in the holey roll alignment was not immediately possible, the machine was started and a satisfactory improvement in single position MD profiling was observed. Here, it is also interesting to note that the average unstability was higher at the centre i.e. at position 3-7 of the profile indicating the possibility of nonlinearity in holey roll.
